Demonstration Truck Program 8. Field Test of a Quieted International Harvester F-4370 Heavy-Duty Diesel Truck

Bolt Beranek and Newman, Inc.
Cambridge, MA

EPA 550/9-82-331H

December 1981

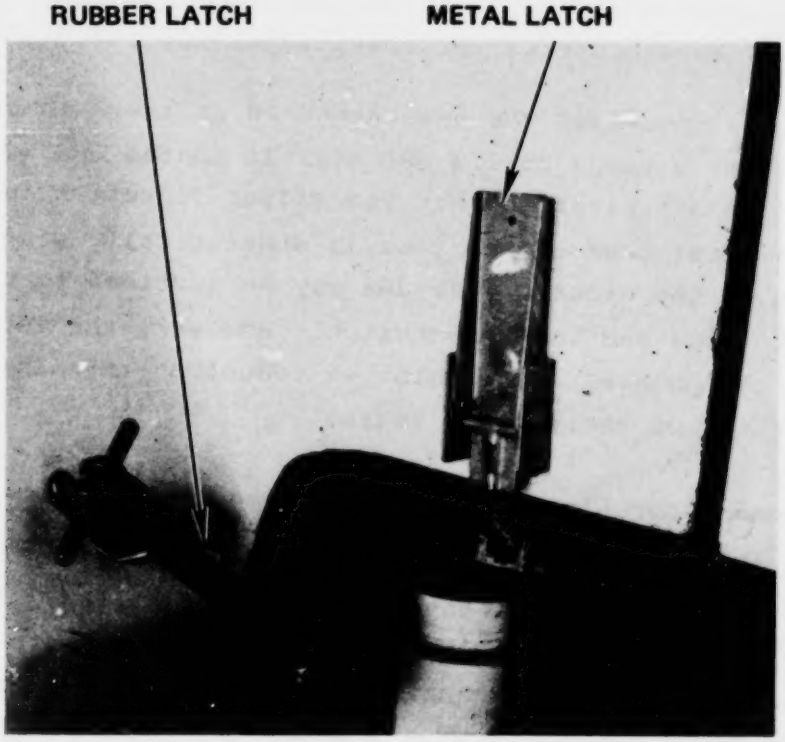
Notable exceptions were failures of various latches and fasteners, which have been chronic problems on other trucks as well. Figure 10 shows that the hook is missing on the metal latch used to hold the hood securely in place. It is believed

FIG. 10. VIEW OF LEFT SIDE OF HOOD WITH METAL LATCH IN UP (i.e., OPEN) POSITION TO REVEAL MISSING HOOK.

that this adjustable latch was simply tightened too much, and a new hook will be installed.

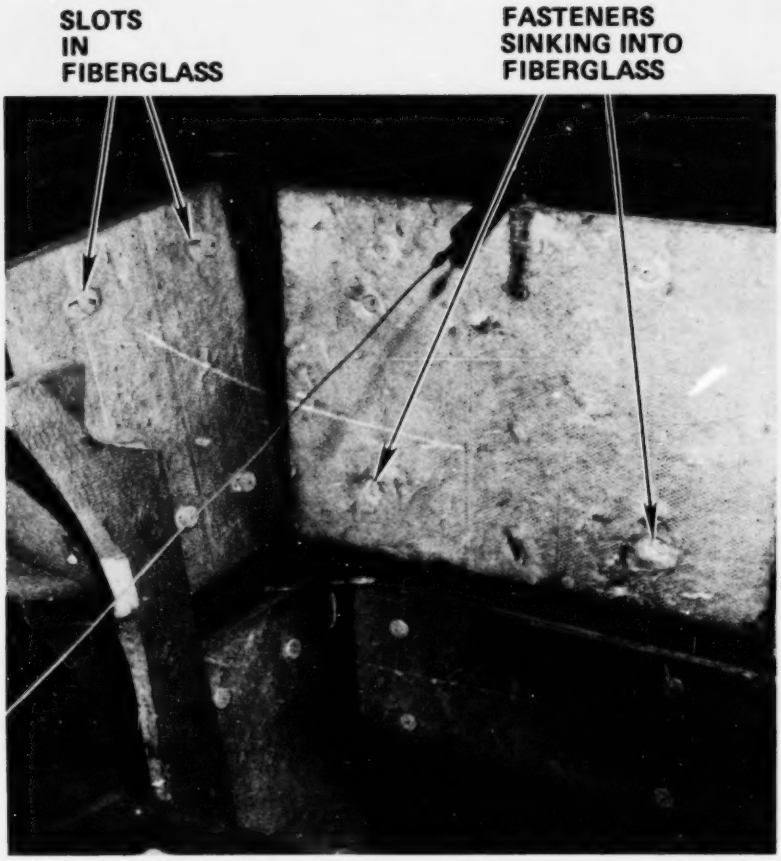
The unfaced fiberglass installed under the hood showed signs of deterioration. Figure 14 shows the underside of the hood tipped forward when viewed from above the engine. On the panel in the upper left corner of Fig. 14, slots may be observed adjacent to the fasteners. These slots developed as the panel moved downward. The broad heads of the fasteners in one of the center panels appear to be sinking into the fiberglass as it pulls away from the hood. Dirt had built up somewhat on the forward panels (in the bottom of Fig. 14) but hardly at all on the rear panels.

FIG. 14. VIEW OF UNDERSIDE OF HOOD SHOWING CONDITION OF UNFACED FIBERGLASS.

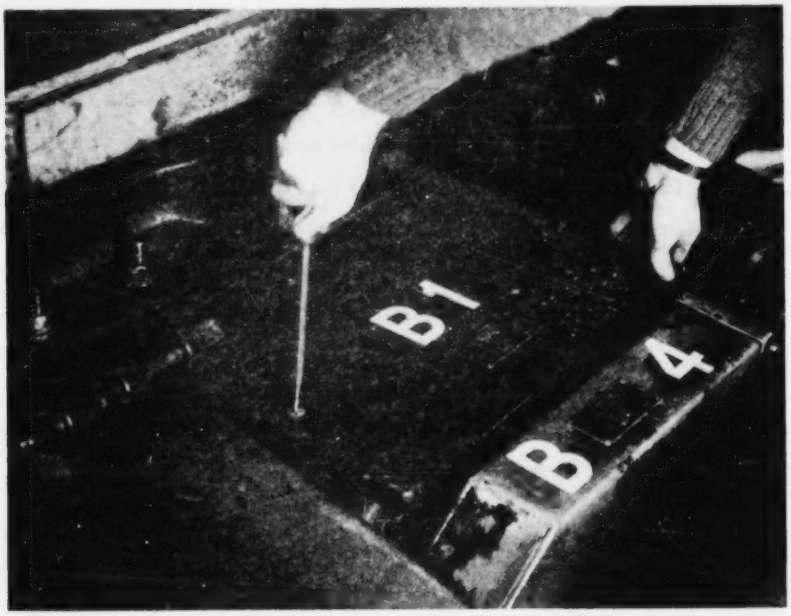
Much of the truck maintenance is performed from beneath the vehicle. To access major drive train service points (e.g., lubrication fittings), it is necessary to remove and replace panels. Figure 16 shows how one of the panels is removed by releasing quarter-turn fasteners with a screw driver. However, as discussed in Sec. 4.2, these fasteners were found to be unreliable and were replaced with rubber side latches.

FIG. 16. REMOVAL OF PANEL B1.

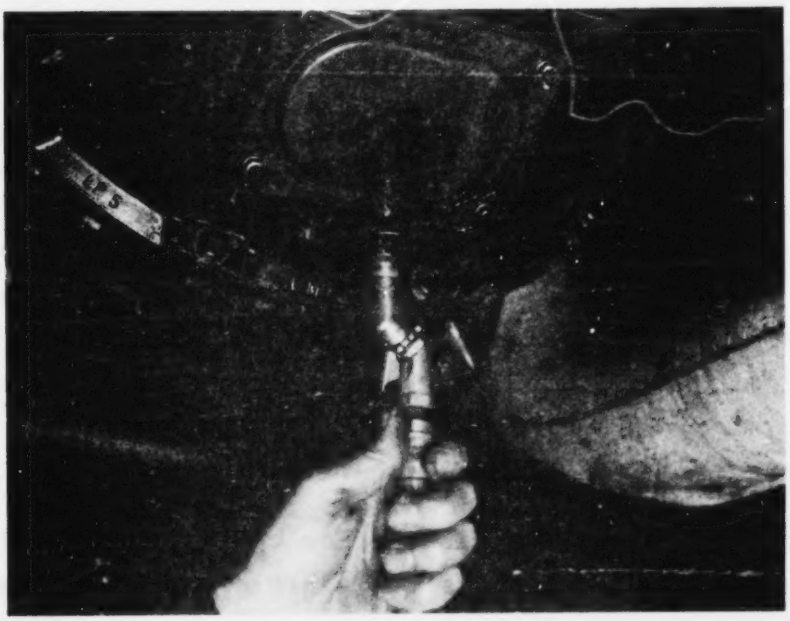
With the panels removed, most maintenance points are readily accessed. Figure 17 shows a mechanic lubricating the throwout bearing. The vehicle operator found that the right rear side panel R4 (see Fig. 3) severely restricted access to the oil filter. An access door in the panel would probably have alleviated this problem.

FIG. 17. LUBRICATION OF THROWOUT BEARING.
